SMALL PROJECT

PBK, Inc. • Scott Toller

DALLAS HALL, SOUTHERN METHODIST UNIVERSITY

Dallas, Texas

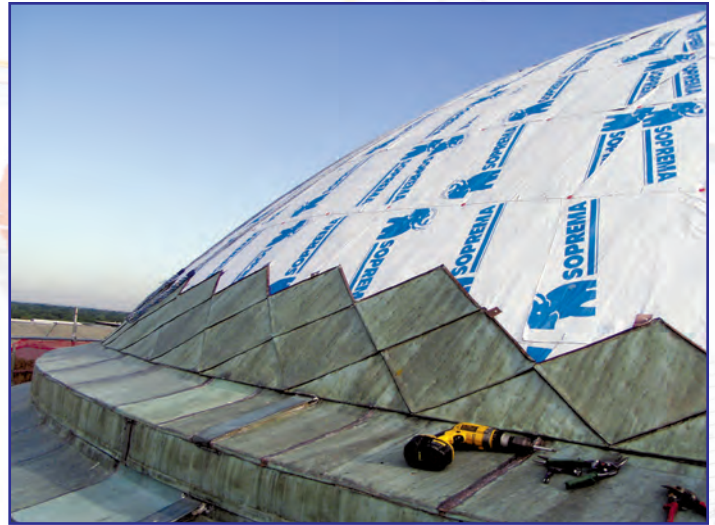
Waterproofing dome with diamond tiles being reinstalled.

PBK's only fear was that, theoretically, the dome should grow in circumference, adding the extra waterproofing. Several of the copper sheets on the flat step area that had some damage were replaced with pre-patinated copper sheets, as they would not be seen from the ground. Reinstallation was started at the front of the building, going in both directions until the rear was reached. PBK's assumption that the dome had grown was correct. The pieces from the flat steps were used to cut out pieces to stitch the backside. It matched beautifully,

and no one would know the difference between the old and the new.

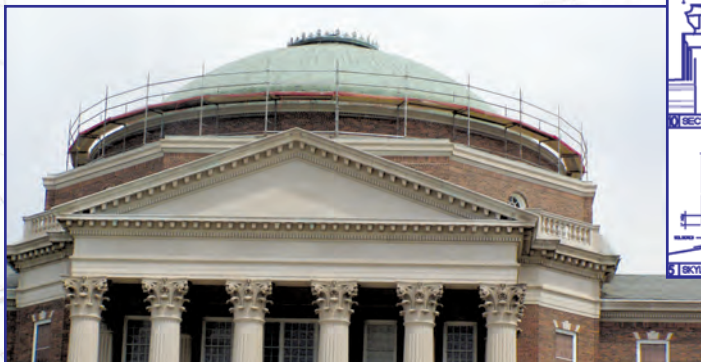
Completed project prior to the scaffolding's coming down.
